EXECUTIVE SUMMARY

The Hubble Space Telescope (HST) was launched aboard the Space Shuttle Discovery on April 24, 1990. During checkout on orbit, it was discovered that the telescope could not be properly focused because of a flaw in the optics. The HST Project Manager announced this failure on June 21, 1990. Both of the high-resolution imaging cameras (the Wide Field/Planetary Camera and the Faint Object Camera) showed the same characteristic distortion, called spherical aberration, that must have originated in the primary mirror, the secondary mirror, or both.

Continued analysis of images transmitted from the telescope indicated that most, if not all, of the problem lies in the primary mirror. The Board's investigation of the manufacture of the mirror proved that the mirror was made in the wrong shape, being too much flattened away from the mirror's center (a 0.4-wave rms wavefront error at 632.8 nm). The error is ten times larger than the specified tolerance.

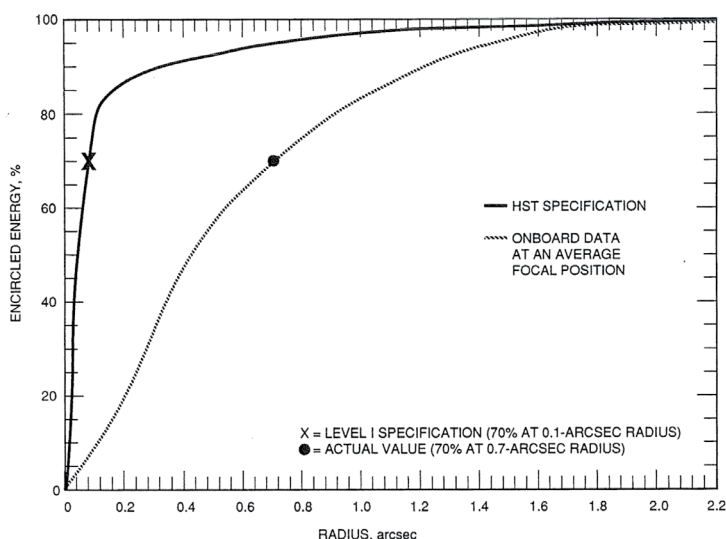
Corrections to the imaging defects due to misalignment were attempted by tilting and decentering the secondary mirror, but these adjustments did not improve the wavefront or the image quality. Further analysis and computer simulation of the WF/PC images indicated that 0.5-wave rms wavefront spherical aberration at 547 nm (equivalent to 0.43-wave rms wavefront error at 632.8 nm) existed in the telescope (Figure 6-1). When interferograms taken by the WFS also indicated severe spherical aberration, the HST Project Manager was notified, and the Contingency Plan was put into effect.

Figure 5-1. Encircled energy versus arcsecond radius of image produced by the HST.

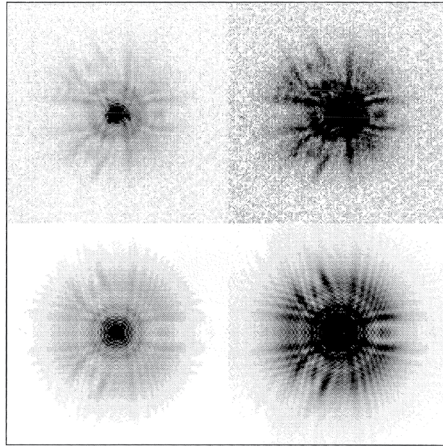
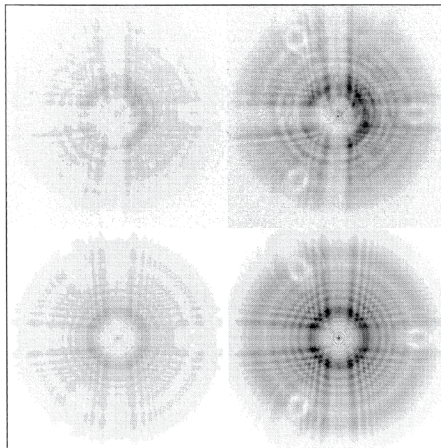
(a) Recorded image of the PC5 star taken on June 14, 1990, with a 0- μm inside focus.

Figure 6-1. Planetary Camera images versus computer simulations. The images in the top frames were taken with the Planetary Camera; those in the bottom frames are computer simulations created using an optical model with 0.5-wave rms wavefront error at 547 nm.

(b) Recorded image of the PC5 star taken on June 21, 1990, with a -300- μm inside focus.

Figure 6-1 (continued). The images in both (a) and (b) show a linear-intensity display on the left, and a logarithmic ("stretched") image display on the right. The focal position denotes the position of the secondary mirror. (Data were supplied by Dr. Jon Holtzman.)

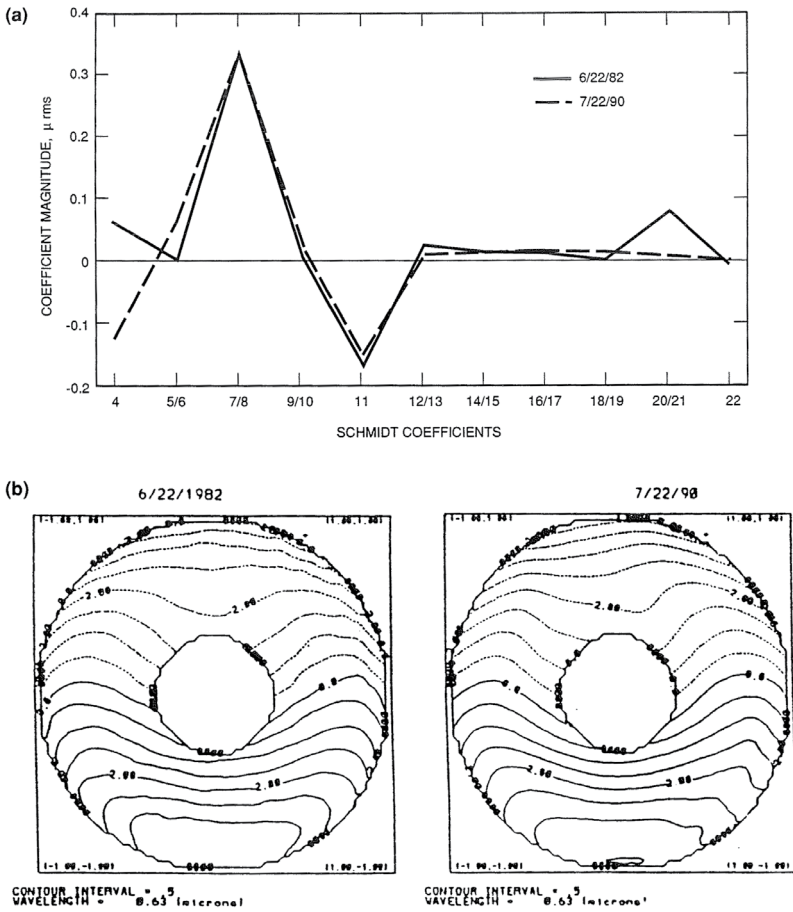
The first test performed on the RNC was to insert the INC and take an interferogram on July 22, 1990. This interferogram was analyzed and compared with a previous interferogram taken with the INC in place. (This latter interferogram was found in a notebook of a P-E employee and was dated June 22, 1982.) Comparison of these two interferograms (Figure 6-2) shows virtually identical results, clearly indicating the existence of spherical aberration. These INC interferograms are corroborated by the RvNC interferograms, which also show spherical aberration (as discussed in Appendix D, Figure D-2). The combination of these interferograms led the Board to conclude that the CORI/RNC assembly is now essentially in the same state of operation as it was at the time the final measurements were made on the primary mirror.

Figure 6-2. Comparison of 1982 and 1990 inverse null corrector data. (a) The coefficients which define the magnitude of various distortions to the wavefront were measured by the INC when it was inserted in front of the RNC in 1982 and in 1990. (b) The coefficient data were extracted from these plots of the interferograms.

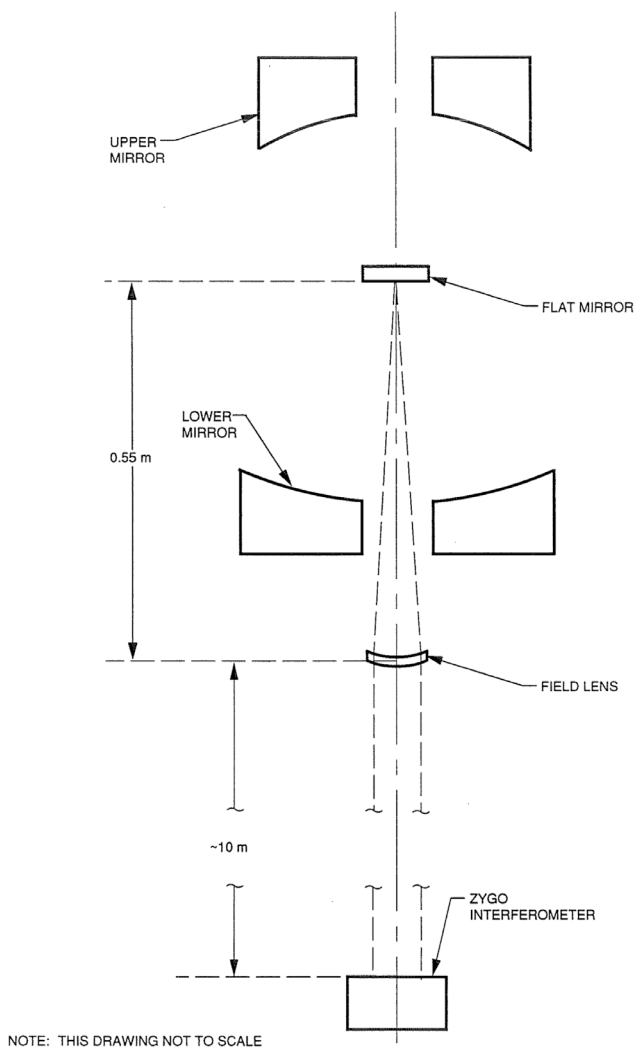
In addition to the optical test used to detect the field-lens spacing error, a direct physical measurement was made from the field lens to the vertex of the lower mirror (Figure 6-4). A lightweight spacing rod and a new vertex plug were made. The results verified the previously measured spacing error to ± 0.1 mm. More accurate measurements of the displacement error will be done at a later time, as this information is necessary for an accurate determination of a prescription for the recovery optics.

Figure 6-3. The 1990 spacing measurement between the field lens and the lower mirror of the reflective null corrector, using an optical test.

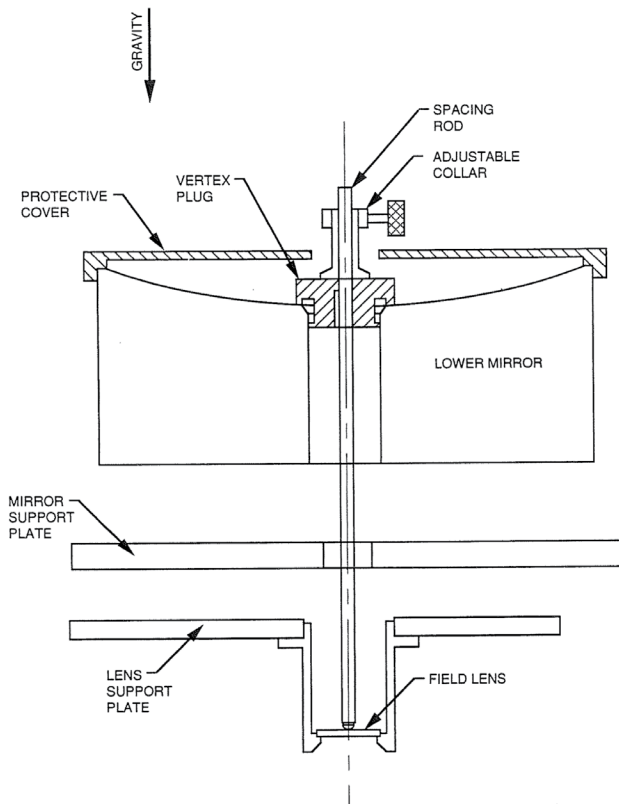
Figure 6-4. The 1990 spacing measurement between the lower mirror vertex and the field lens of the reflective null corrector, using a mechanical technique.

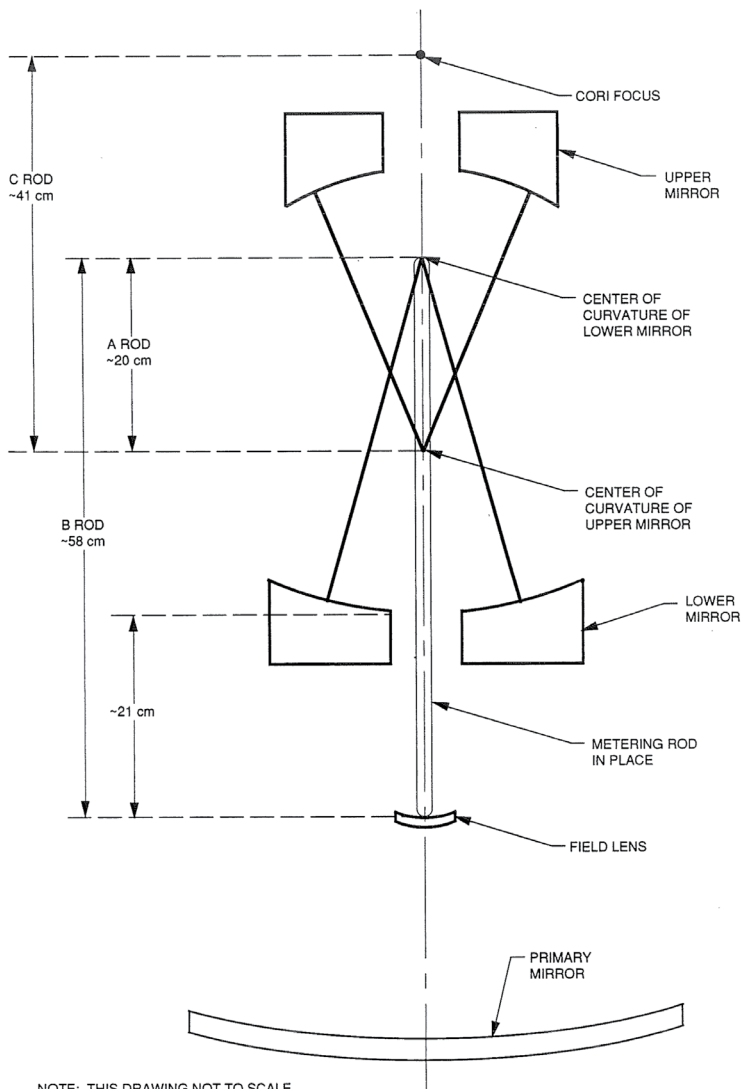
There were three metering rods (labeled A, B, and C) made of Invar, a metal with a small temperature expansion coefficient. The ends of the metering rods were rounded and polished because the very precise positioning of the optics in the RNC used an interferometer, rather than a mechanical measurement. This procedure involved auto-reflecting a focused beam of light off the end of a rod and observing an interference pattern from the beam that came back on itself. Centering the light beam on the rod end was essential for the measurement. To prevent the metering rod from being misaligned laterally with respect to the interferometer axis, P-E decided to attach "field caps" to one end of the rod (Figures 7-2 and 7-3). The field caps were fitted over the rod ends and had a small aperture in the center to ensure centering of the rod on the beam. The top surface of the field cap was covered with nonreflecting material; however, some of this material had, apparently inadvertently, broken away from a small area around the field cap aperture. It appears that the operator obtained reflection from the field cap where the nonreflecting material was absent, rather than the rod end, causing the 1.3-mm misspacing. A test performed in 1990 with the equipment showed that it was quite easy, even probable, to make this error with the configuration used. Figure 7-4 indicates how the displacement error occurred by reflecting light off the field cap, rather than the rod end, as designed. Figure 7-5 is a photograph of the field cap and shows the specular region around the aperture. (In this photograph, the broken-away coating appears darker than the surrounding region.)

Figure 7-1. Position of metering rods used to space optical elements in the reflective null corrector.

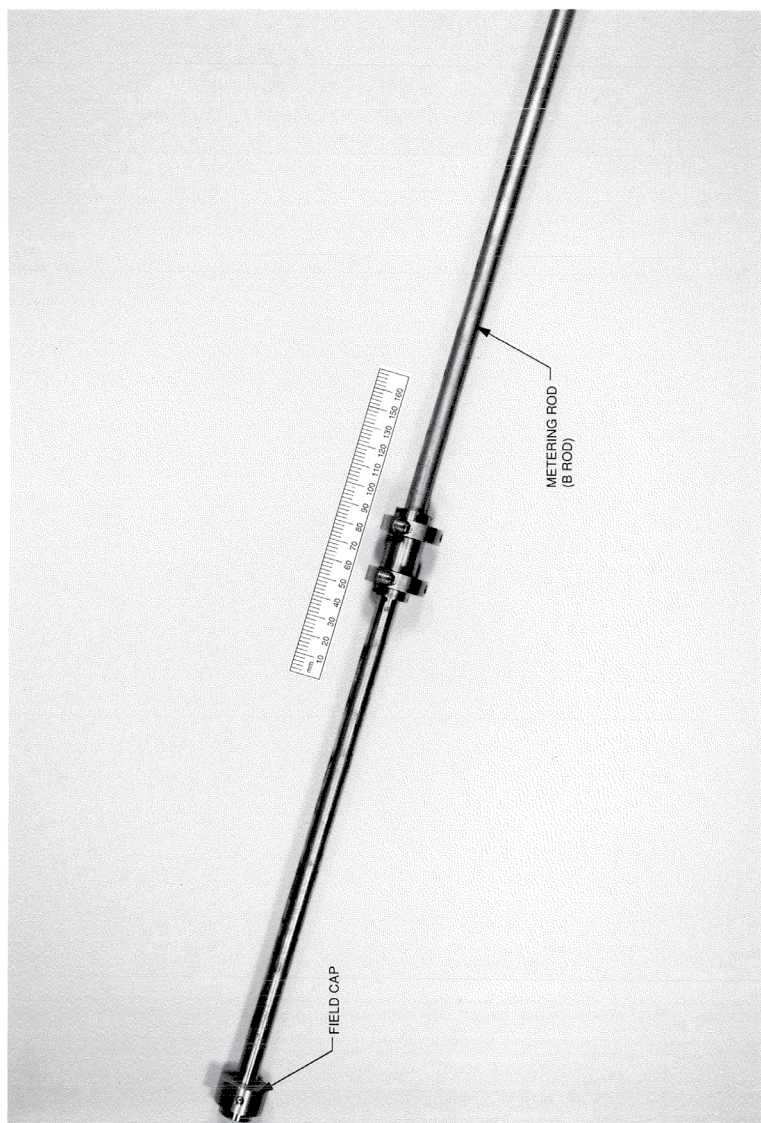
Figure 7-2. Metering rod (B rod) used to space the field lens and the center of curvature of the lower mirror in the reflective null corrector.

With one end of the metering rod presumably located at the center of curvature of the lower RNC mirror, the field lens was then brought up to the end of rod B, but there was no adjustment left in the screws used for this positioning. More adjustment room was made by inserting spacers between the field lens and the lower mirror mounting plate. The adjustment mechanism was found not to be staked. Staking, i.e., securing the mechanism to prevent inadvertent movement, was a specified procedure. The final location of the field lens was then set with the addition of the spacers. As a result, the field lens was about 1.3 mm too far from its correct position relative to the lower mirror.

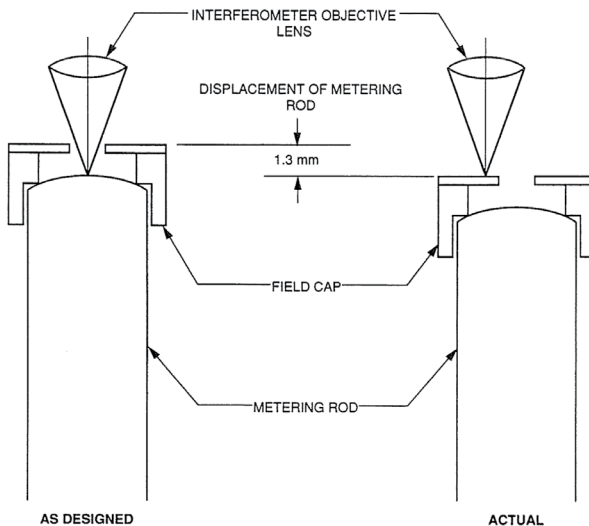
It has been established that the field lens was approximately 1.3 mm too far from the lower mirror of the RNC, which was used to figure the primary mirror. The RNC and its associated interferometer were found in the test chamber, unused and unchanged since the completion of the HST program. The RNC was measured in situ, and there is high confidence that the spacing error existed during the fabrication and test of the HST primary mirror. The cause of the spacing error, on the other hand, becomes a matter of conjecture, because the records necessary to reproduce what actually happened were not found. The scenario given below reproduces the events and provides a rationale of how the spacing error occurred. This scenario was simulated in the laboratory under the guidance of the Board and is the most likely cause of the error.

Figure 7-4. Displacement due to the interferometer focusing on the field cap instead of the metering rod.
