EXECUTIVE SUMMARY

The Hubble Space Telescope (HST) was launched aboard the Space Shuttle Discovery on April 24, 1990. During checkout on orbit, it was discovered that the telescope could not be properly focused because of a flaw in the optics. The HST Project Manager announced this failure on June 21, 1990. Both of the high-resolution imaging cameras (the Wide Field/Planetary Camera and the Faint Object Camera) showed the same characteristic distortion, called spherical aberration, that must have originated in the primary mirror, the secondary mirror, or both.

Continued analysis of images transmitted from the telescope indicated that most, if not all, of the problem lies in the primary mirror. The Board's investigation of the manufacture of the mirror proved that the mirror was made in the wrong shape, being too much flattened away from the mirror's center (a 0.4-wave rms wavefront error at 632.8 nm). The error is ten times larger than the specified tolerance.

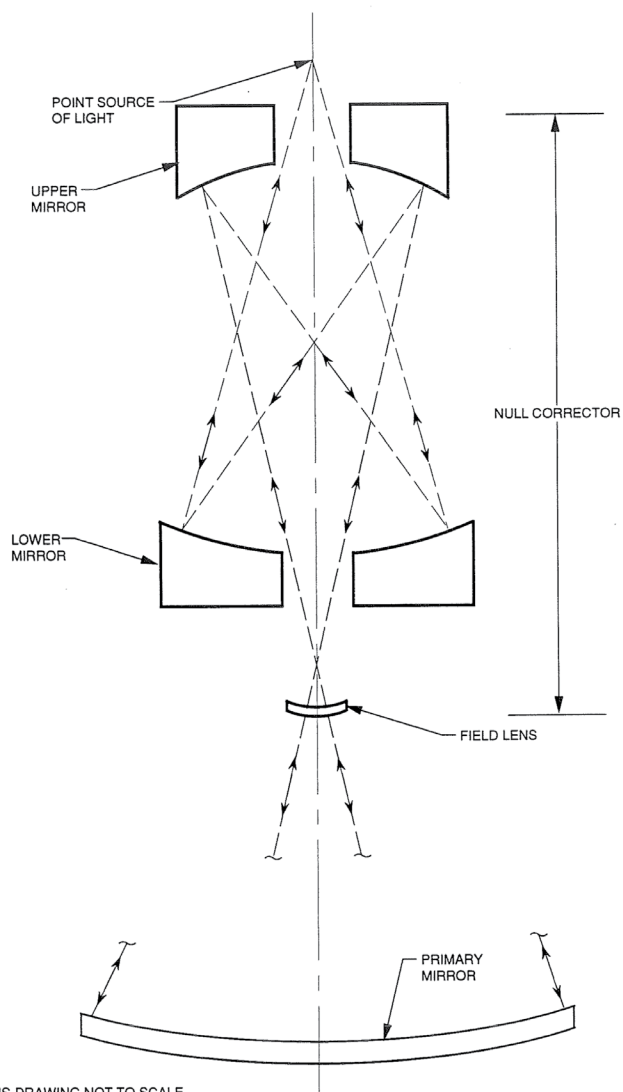
Figure 4-2. Reflective null corrector.

RNC was designed and built by the Perkin-Elmer Corporation for the HST Project. This unit had been preserved by the manufacturer exactly as it was during the manufacture of the mirror. When the Board measured the RNC, the lens was incorrectly spaced from the mirrors. Calculations of the effect of such displacement on the primary mirror show that the measured amount, 1.3 mm, accounts in detail for the amount and character of the observed image blurring.

precision for testing the figure of the primary mirror, and as a result, a new and novel reflective null corrector (RNC) was designed. As shown in Figure 4-2, the Perkin-Elmer RNC consists of two spherical mirrors and one small field lens. (The more common RNC design contains only a single mirror and a field lens.) In the P-E design, the shape of the optical template could be precisely predicted simply by knowing the manufactured dimensions of the two mirrors and the lens, including the lens material, and the spacings of the three optical elements. Perkin-Elmer planned to certify the RNC with great care, and they did not plan to do any independent testing of the mirror.
